Image Rejection Hints

Introduction

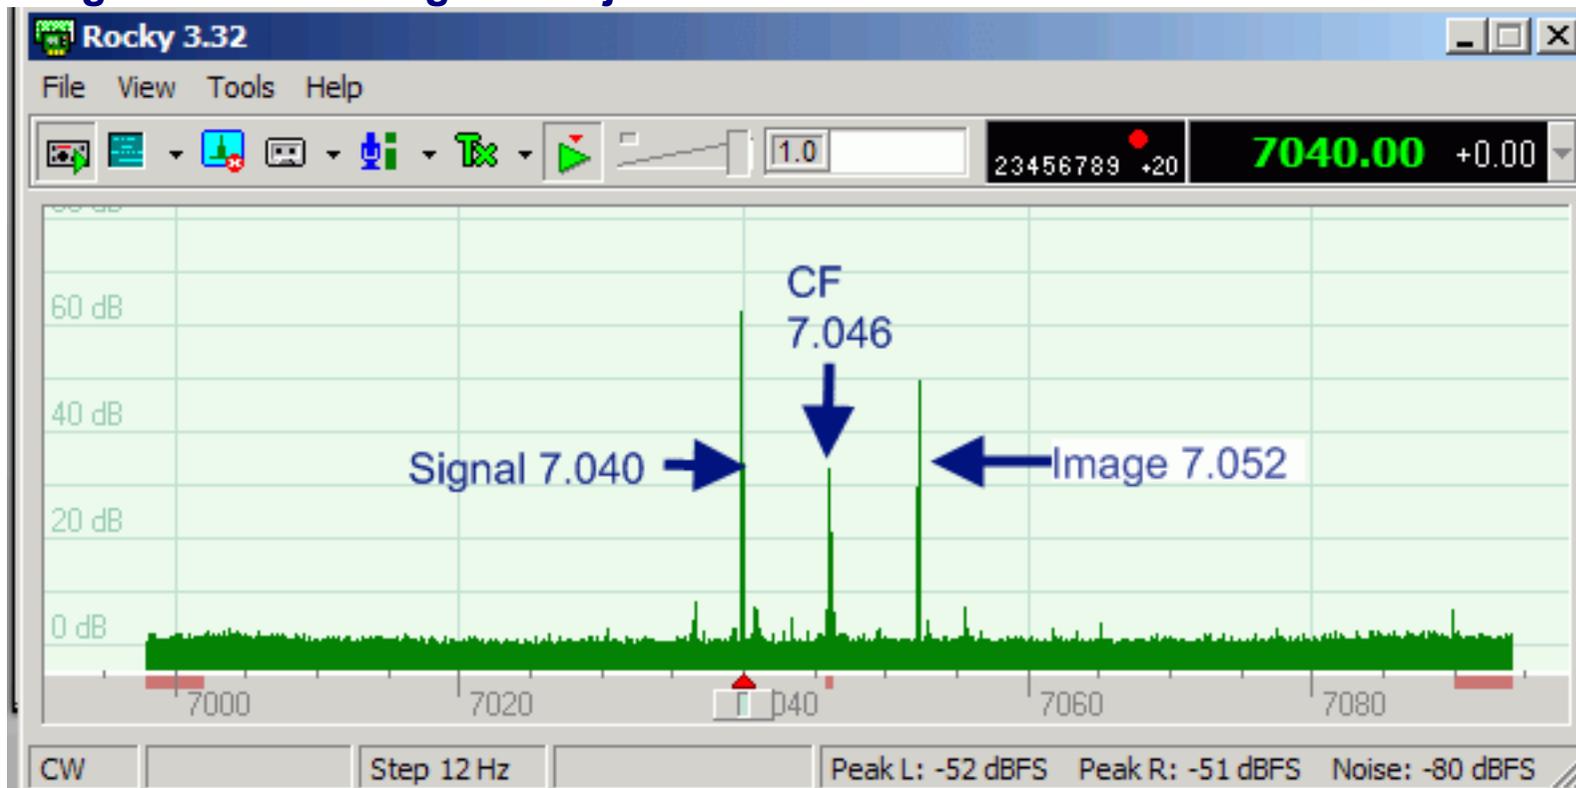
The problem is shown below. Given a Softrock with a center frequency of 7.046 MHz and an injected signal of 7.040 MHz, an image rejection problem exists when the mirror image of the signal exists at 7.052 MHz (opposite side of the center frequency from the desired signal and displaced an equal amount therefrom):

Image Problem - Image not rejected

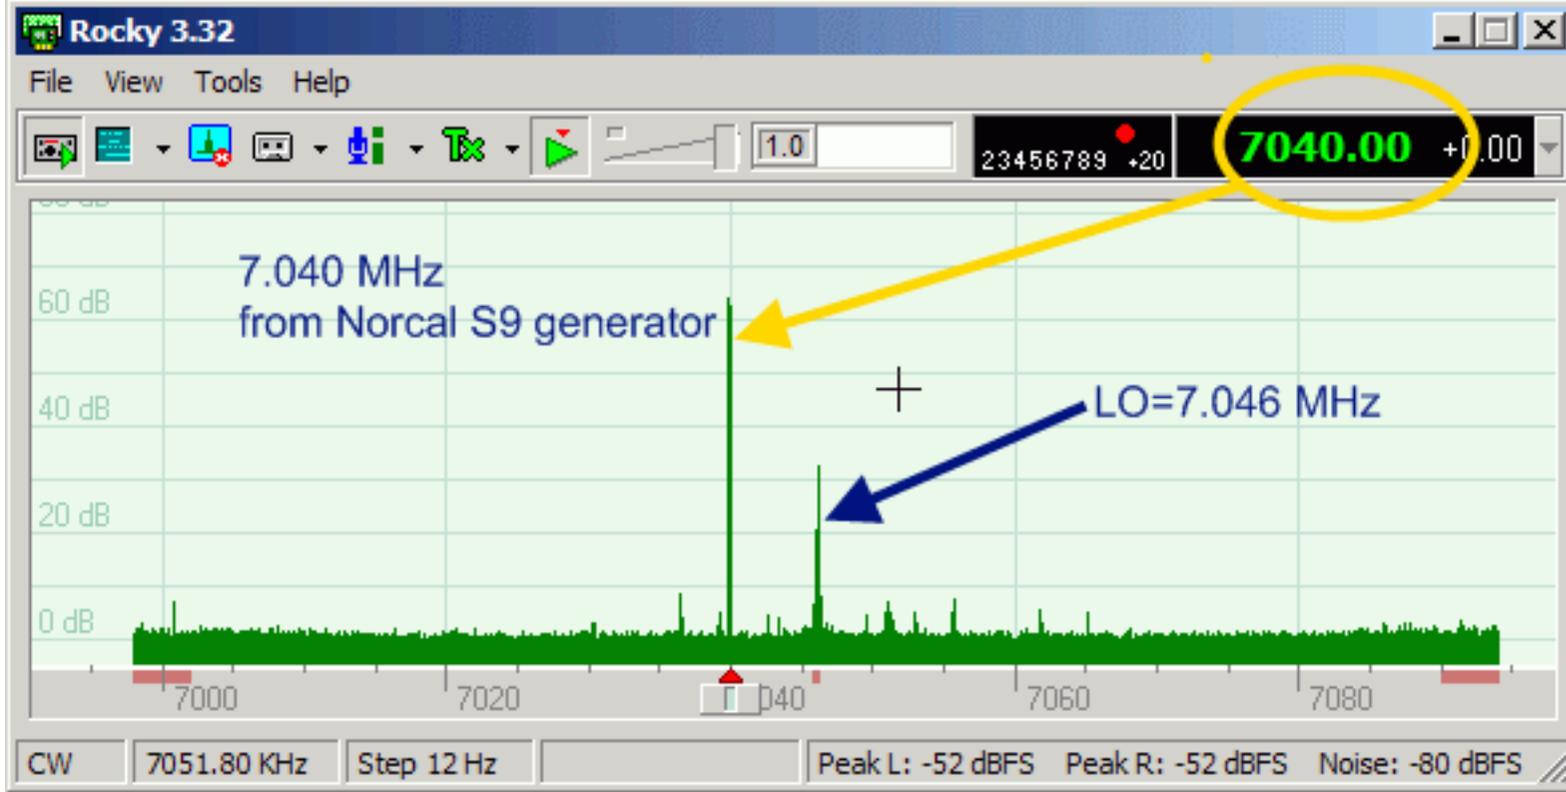
In order to reject unwanted images, the SDR software MUST have two discrete audio inputs - I (In-Phase) and Q (Quadrature) - that are equal in frequency and 90 degrees apart. These inputs make it possible to reject images, as shown below:

Image Rejected
